Cladding fasteners, are they driven correctly?

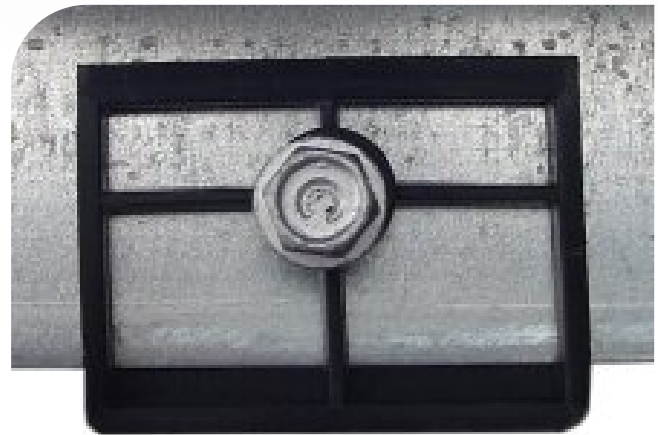
Fig 1: Under driven – cross hairs not deformed

If the fastener does not deform or move the cross hair the fastener is under driven, refer to Fig. 1 opposite.

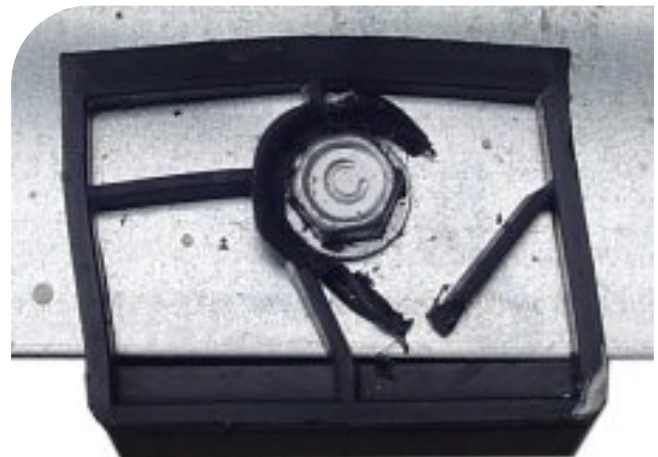
Fig 2: Over driven – cross hairs snapped

If the cross hair has been broken the fastener has been overdriven, refer to Fig. 2 opposite.

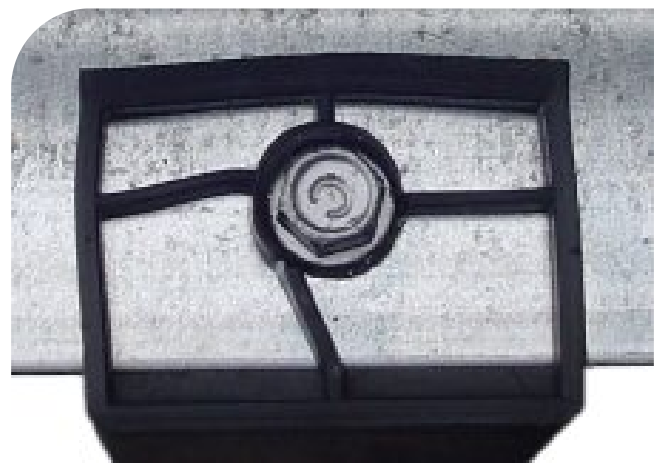
Fig 3: Correctly driven – cross hairs deformed but not snapped

If the cross hair is deformed or twisted without being broken the fastener has been driven correctly, refer to Fig. 3 opposite. This feature allows the sheeting sub-contractor to control the quality of fixing installation.
